**Properties, best management practices and conservation of terraced soils in Southern Europe (from Mediterranean areas to the Alps); a review**

**Properties, best management practices and conservation of terraced soils in Southern Europe (from Mediterranean areas to the Alps): a review**

**S. Stanchi<sup>1</sup>, M. Freppaz<sup>1</sup>, A. Agnelli<sup>2</sup>, T. Reinsch<sup>3</sup>, E. Zanini<sup>1</sup>**

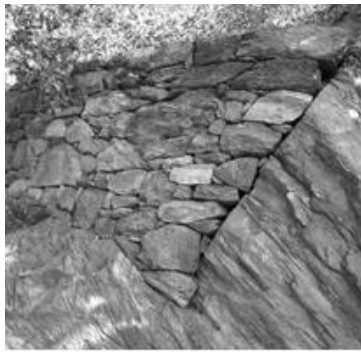
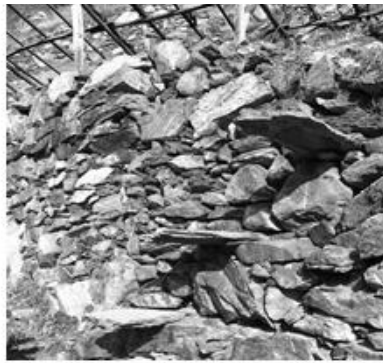
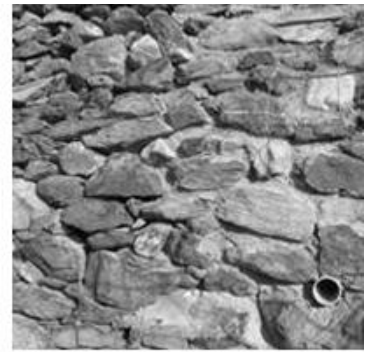
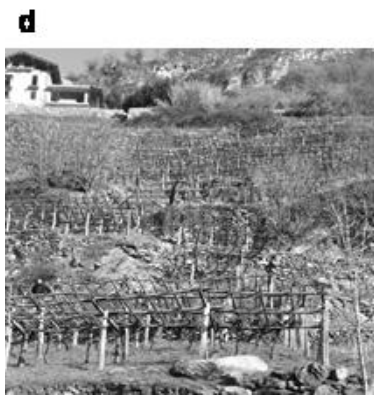
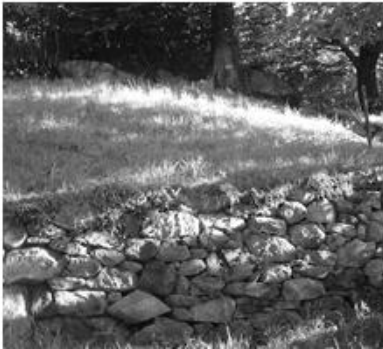
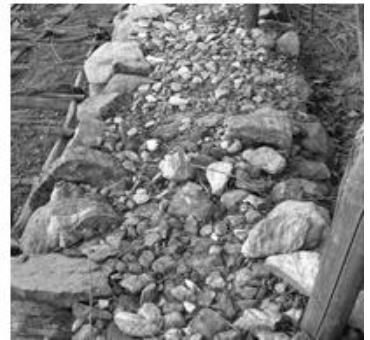
**Figure 2: terraced slopes in Valle d'Aosta. Structural typologies and details (Photos M. Freppaz). a) wall foundation; b) connection between terraces; c) example of restored wall; d) terraced slope - vineyard; d) terraced slope – chestnut wood; e) detail of wall structure**

The most common typologies of terracing (table 2) for the Alpine area were collected in the Alpter database ([www.alpter.net](http://www.alpter.net), Scaramellini & Varotto, 2008). They include: building typology (dry stone, wooden, concrete, solid wall), foundation (on rock, sediments, terrain, mixed material), wall length (from decimetres to hundreds meters), height (from 2-3 decimetres to several meters), wall and tread slope, tread width (very diverse, terracing density, average terrain slope (often more than 100%). Terraces can be linked by ramps, stairs (parallel or perpendicular to walls), suspended stairs, mobile stairs, or mixed systems. The drainage network may be parallel or perpendicular to treads, sometimes overlapping with paths and main accesses (Scaramellini & Varotto, 2008). Figure 2 illustrates some of these features for the terraced area of Aosta Valley Region (NW-Italy).

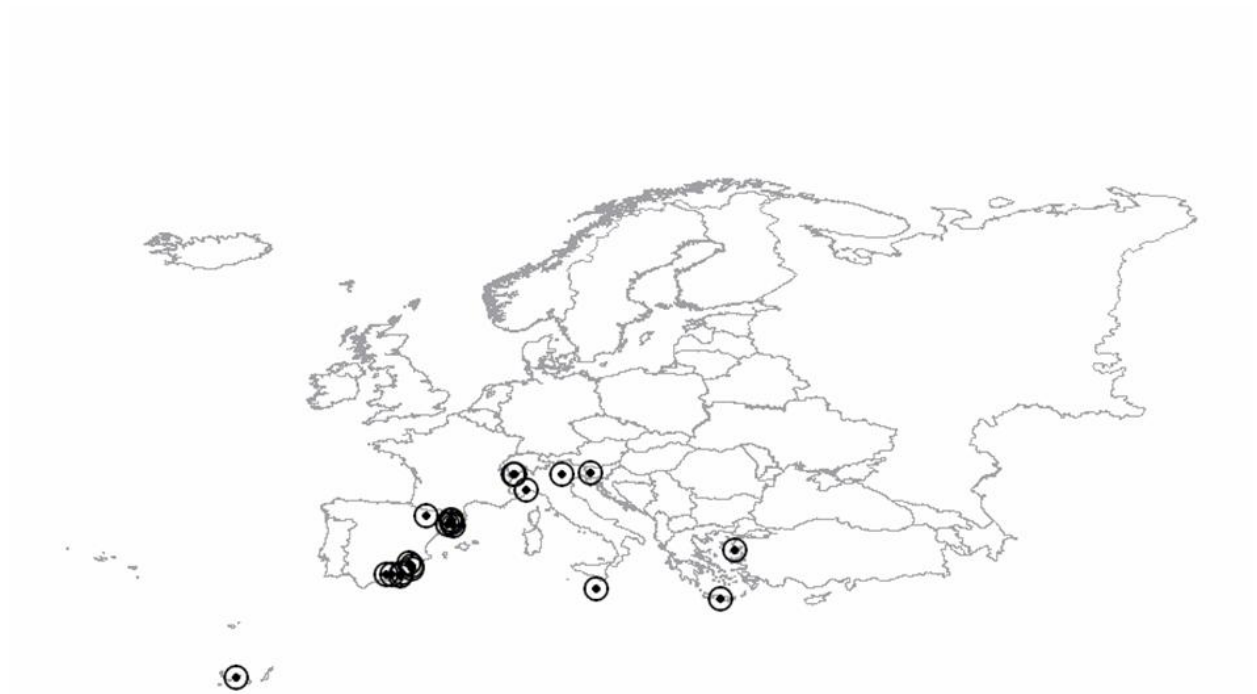
**Figure 3: relevant literature on terraced soils in Southern Europe. The map represents the study area**

While most literature on terraces focuses on the landscape or building aspects, the studies on terraced soils are relatively scarce, and they focus on a few regions (Figure 3). Many studies on terraced soils were carried out in Southern Spain, while a few examples are available for the rest of Southern Europe.
